Figure 2: Conceptual Site Plans and Cross Section(s)

407 & 409 FIRST STREET

ROCK REVETMENT REHABILITATION
CORONADO, CALIFORNIA

DRAWING TITLE:
EXISTING & PROPOSED SECTIONS

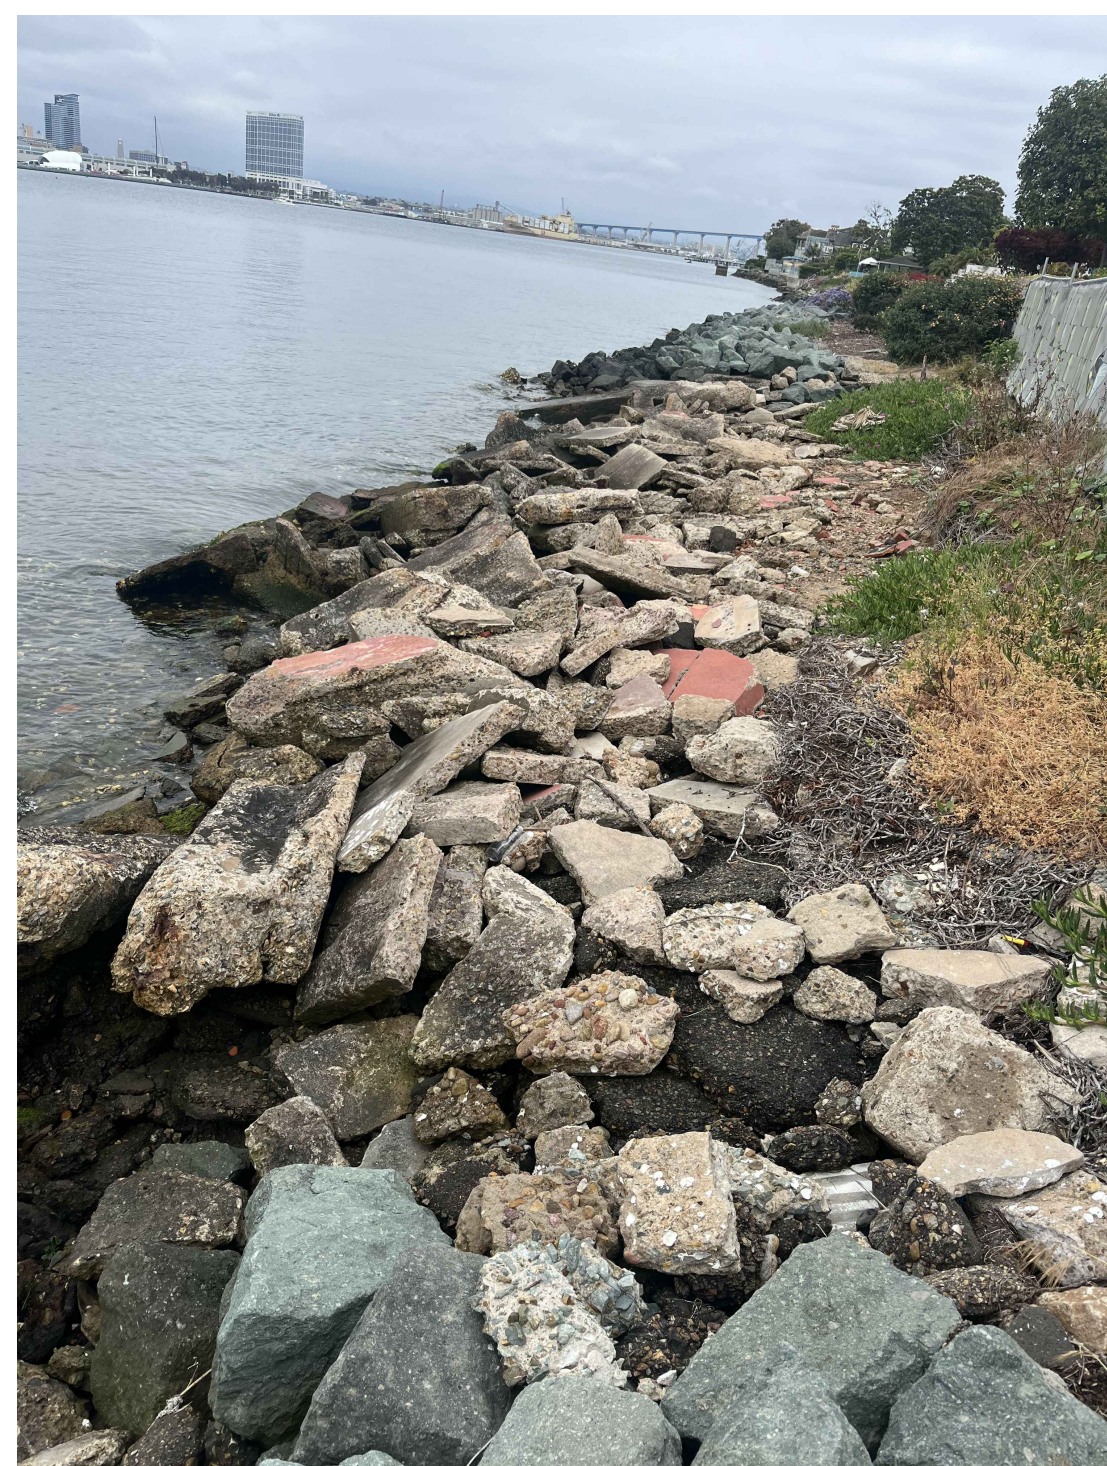
PHOTO 1, LOOKING NORTHWEST AT EXISTING REVETMENT FRONTING 407 1ST STREET. NOTE LOWER HALF OF THE EXISTING REVETMENT HAS SETTLED CAUSING A STEEPENING OF REVETMENT FACE.
